1. REPORT DATE (DD-MM-YYYY) 14-07-2005		2. REPORT TYPE Technical Report		3. DATES COVERED (From - To) Aug 03-Apr 05
4. TITLE AND SUBTITLE Bonded Repair of Corrosion Grind-Outs		5a. CONTRACT NUMBER F05611-03-D-003		
		5b. GRANT NUMBER		
		5c. PROGRAM ELEMENT NUMBER

The US Air Force is operating a large fleet of aging aircraft. Some examples of problems that aging aircraft can encounter are fatigue and corrosion. This research focuses on bonded repair of exfoliation corrosion in the upper wing skin of the E-8C Joint Star (B707) military transport aircraft.

The purpose of the current research is to develop a flush bonded repair method that restores structural integrity to corrosion grind-outs deeper than 25% of the skin thickness, so that severe corrosion cases can be handled without costly repair.

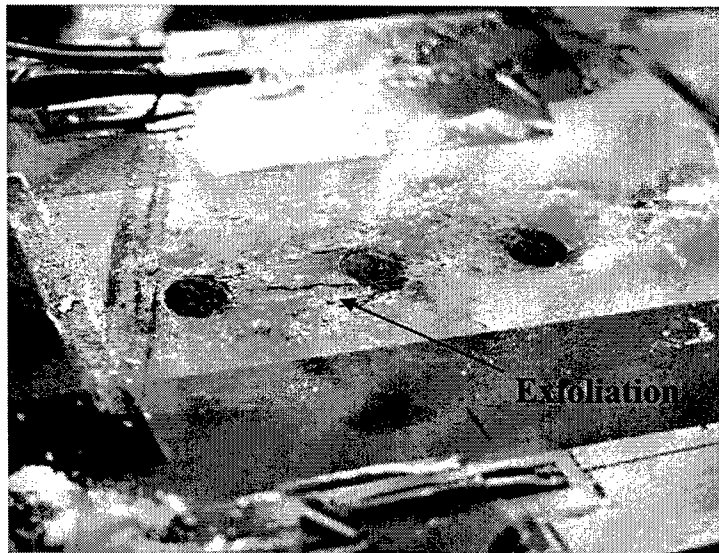
**Figure 2: Example of exfoliation corrosion on upper wing skin**

Upper wing skins on the E-8C, made out of 7075-T6 (and 7178-T6 on earlier aircraft) aluminum, have shown extensive exfoliation damage, mainly around the fastener holes, see Figure 2. Exfoliation corrosion is a form of intergranular corrosion associated with high strength aluminum alloys. Heavily worked alloys with a microstructure of elongated grains are especially susceptible to exfoliation. Corrosion products will build up along the grain boundaries and eventually result in layers of the material peeling or flaking off. Exfoliation often initiates at end grains encountered in locations such as machined holes, and can progress further into the material.

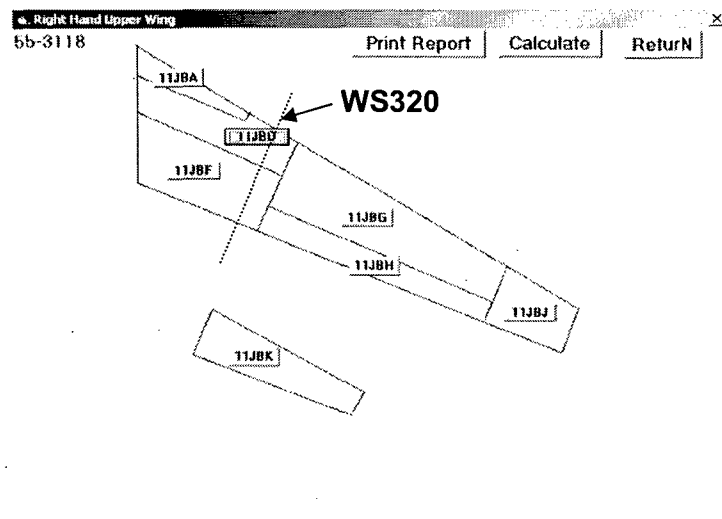
Figure 3: Wing panel locations for B707

The area of interest for this project was wing station (WS) 320, wing panel 11JBD and wing panel 11JBF (see Figure 3 and [2] for the panel locations). Note however that the repair concepts that will be developed here will be more widely applicable, to include other areas of the upper wing skin.

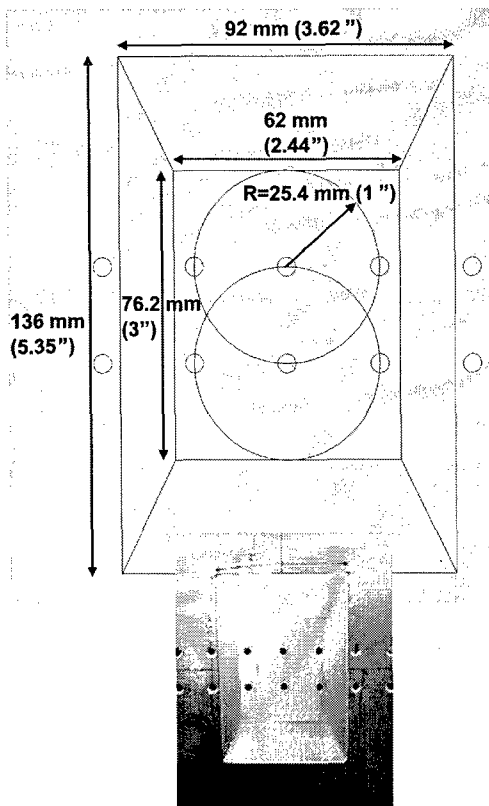
Figure 4: Grind-out for aluminum repair

To shape the grind-outs for this project, it was assumed that two adjacent fastener holes have corrosion damage with a diameter of 50.8 mm, see the overlapping circles in Figure 4 and Figure 5. The area covered by these 2 circles was then approached by a rectangular area in which the corrosion depth was assumed constant with a depth of 3.175 mm. The blend out lengths were then added. The use of a rectangular patch is preferred because the edges of circular patches are inefficient, due to the absence of sufficient overlap length along the edges.

Following the T.O. requirements of tapering in two directions resulted in a grind-out that is shaped as a pyramid-without-top (Figure 4). By omitting the taper perpendicular to loading direction, the second type of grind-out was formed (Figure 5).

As was mentioned already in paragraph 2.1, two different tapers were used for the grind-outs, see Figure 4 and Figure 5. To verify that the strains in and around these two different types of grind-outs were not significantly different; specimens were tested with back-to-back mounted strain gages in order to determine the membrane and bending strains. Specimens were loaded up to a stress level of 120 MPa (17.4 ksi).

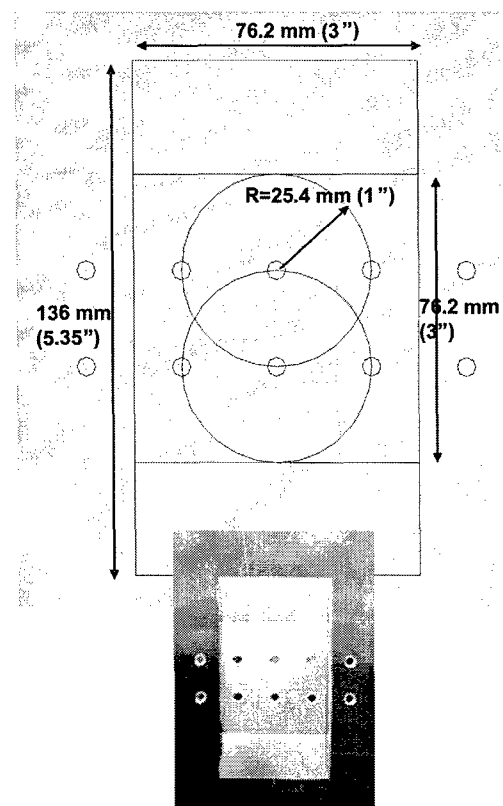
Figure 5: Grind-out for boron and hybrid repair

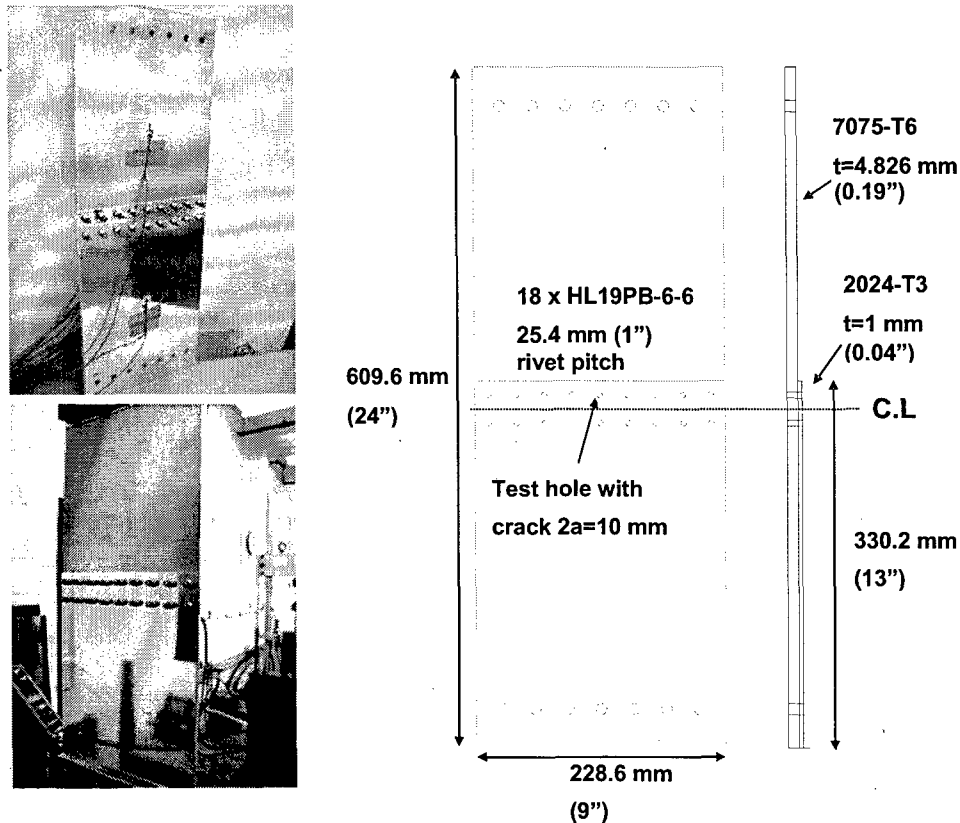
Figure 6: Specimen dimensions

Figure 6 shows the dimensions of the specimen with a single bolt row in the grip area. These specimens were used for tests where there was no load reversal, only tension-tension or compression-compression. There were also specimens with a double row of bolts to prevent the specimen from slipping in the grips when the loads are changing direction. The extra two rows were added to each end of the specimen, making the total length of the specimen 660.4 mm (26"). Note that the gage length of the specimens (length of free specimen between the steel grips) remained the same for both configurations, 501.5 mm (19.75")

In order to create the necessary load transfer through the hi-loks, a sheet of 2024-T3 bare aluminum with a thickness of 1 mm (0.04") was attached to the specimen. The length of this thin sheet is half the specimen length plus 25.4 mm (1"), see Figure 6. The thin sheet was fastened using two rows of nine hi-loks, centered around the horizontal centerline of the specimen. The rivet pitch was 25.4 mm (1").

As can be seen in Figure 6, the top center rivet hole had a through-crack on both sides of the hole. There were several reasons for making a starter crack in this location:

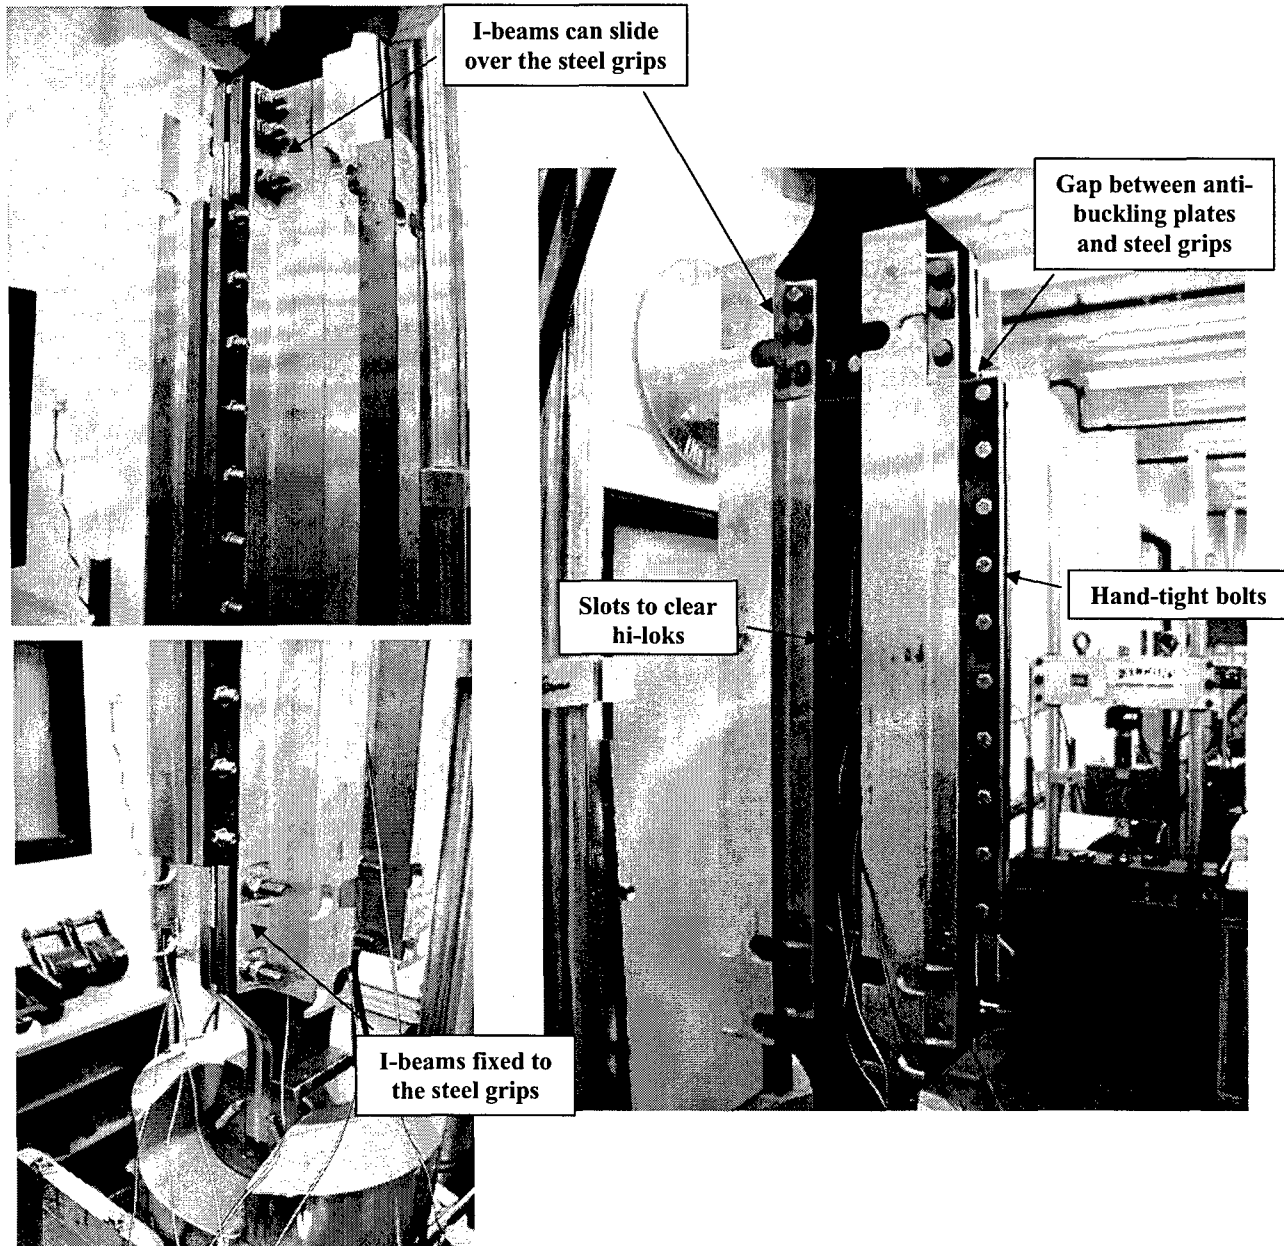
Figure 7: Anti-buckling test set-up

Since the specimen would not be able to withstand the high compressive loads, anti-buckling plates combined with four I-beams were used to support the specimen, see Figure 7. The two steel anti-buckling plates, each with a thickness of 12.7 mm (0.5"), were attached to either side of the specimen. The steel plates were covered with Teflon sheets to prevent friction build-up. The plates were attached using two rows of bolts that are hand-tightened. To avoid friction between the anti-buckling plates and specimen, it is important not to clamp the anti-buckling plates onto the specimen. Clamping the anti-buckling plates onto the specimen could lead to load transfer through the steel plates, which is unwanted. The limited amount of play that is necessary between the plates and specimen will result in the desired amount of bending in the specimen.

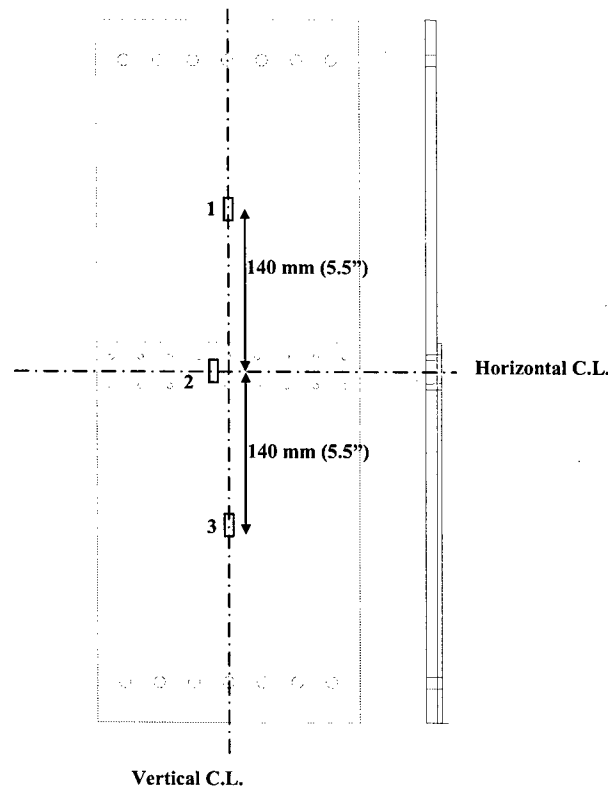
Figure 8: Strain gage locations

To verify that the loading requirements were met, a specimen was instrumented with 6 strain gages (Micro-Measurements CEA-13-125UN-350). The gages were placed along the length of the specimen, location 1 and 3 are located on the vertical center line of the specimen, location 2 is on the horizontal center line of the specimen but is offset 12.7 mm (0.5") in horizontal direction (half the rivet pitch).

Gages are mounted back to back so that bending strains can be measured. Also note that locations 2 and 3 are in the area where the 1.0 mm (0.04") thin sheet is mounted. Holes were made in the thin sheet to allow the strain gage wires to be routed.

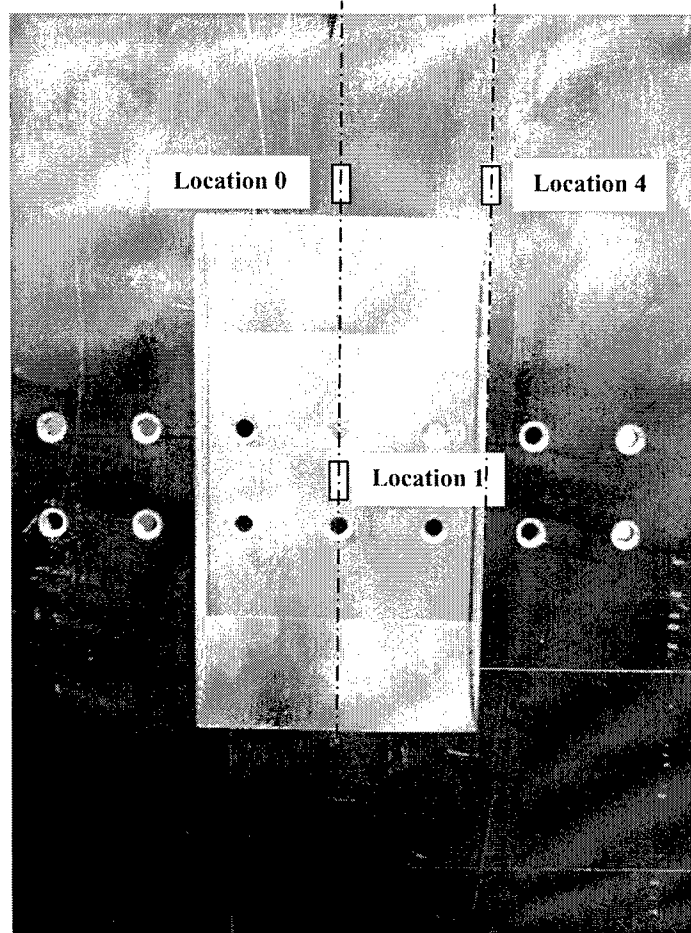
Figure 9: Strain gage locations (note that the tests were performed without the rivet holes present)

Figure 9 shows the three strain gage locations that are most interesting: location 1 at the center of the grind-out; location 0 on the vertical centerline of the grind-out at the tip of the grind-out; location 4 at the corner of the grind-out. More specific information about the locations of these and additional gages can be found in [5].

For the grind-out with double taper, location 4 was located at the corner of the two intersecting tapers. Also note that the strains were measured without the rivet holes present.

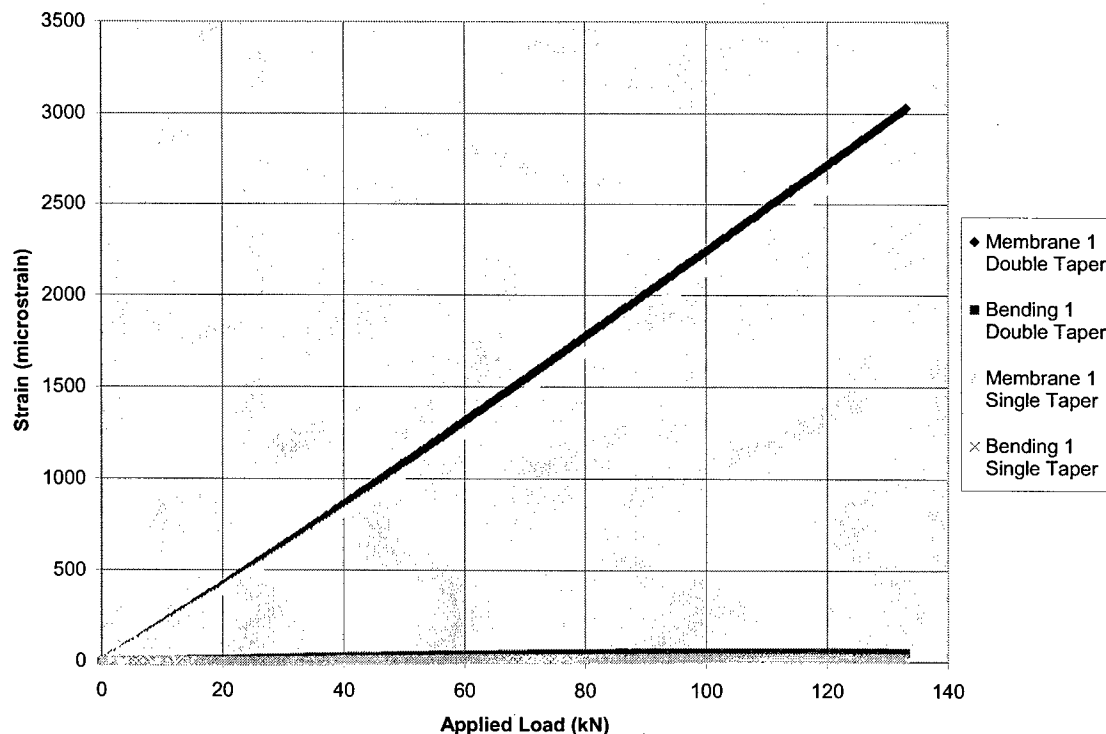
Figure 10: Membrane and bending strains for location 1 for panels with double and single taper

Figure 10 shows the strain-load data for location 1 for the two different grind-outs. At the maximum applied load, the grind-out with single taper has a membrane strain that is approximately 4.8% lower than the membrane strain for the grind-out with double taper. Apparently, the grind-out with double taper, which is a little bit wider than the grind-out with single taper, allows for a slightly lower amount of load bypass. It can also be seen that the bending in the center of the grind-outs is almost zero but it must be noted that there is no thin half sheet attached.

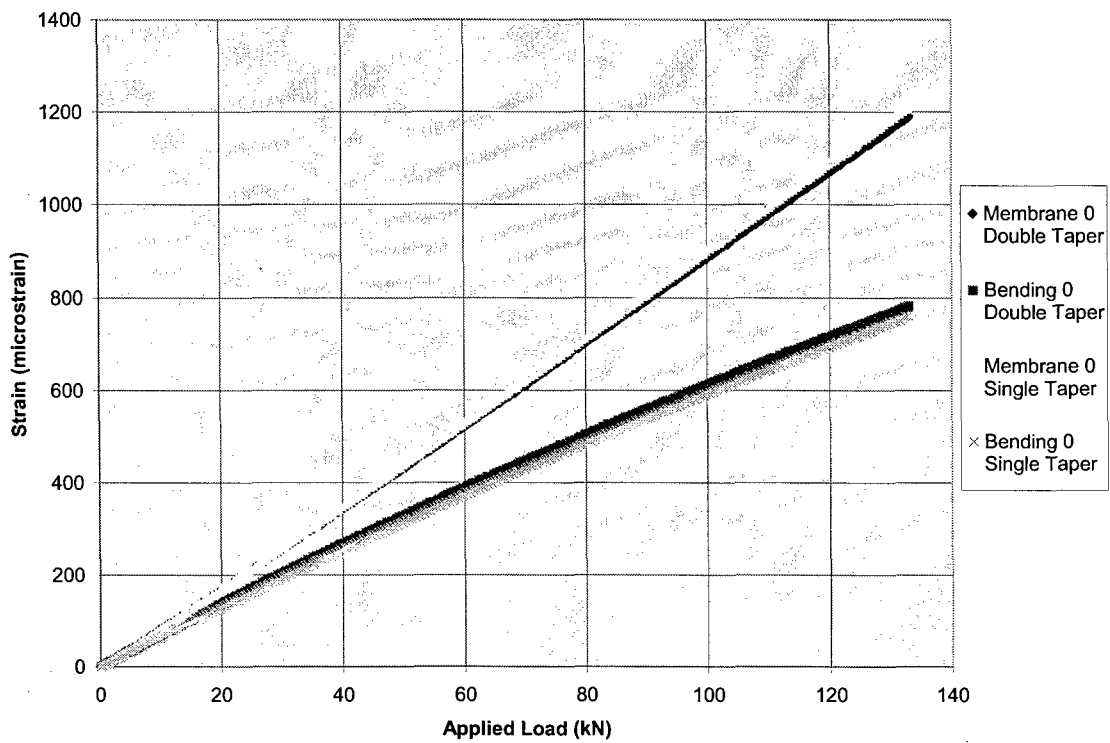
Figure 11: Membrane and bending strains for location 0 for panels with double and single taper

Figure 11 shows the membrane and bending strains at the run-out of the grind-out. It can be seen that the difference in membrane stresses is less than 1% at the maximum applied load. There is, as expected, a significant amount of secondary bending but the amounts of bending are very close to each other for the two different types of grind-outs.

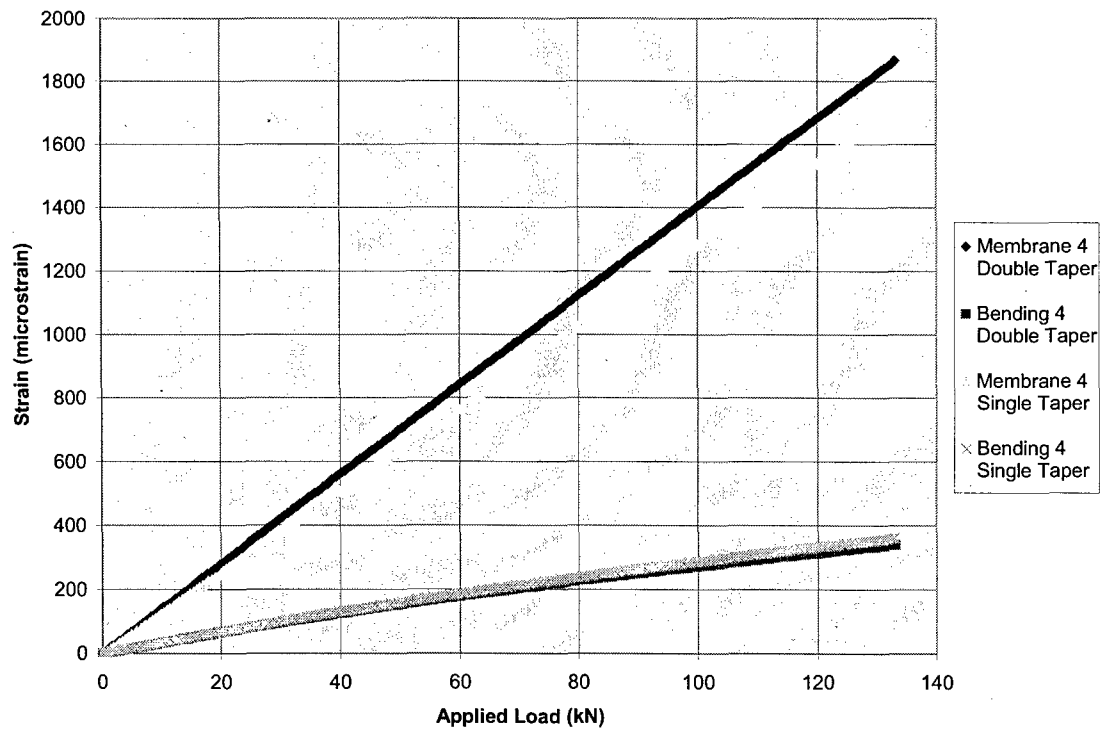
Figure 12: Membrane and bending strains for location 4 for panels with double and single taper

Figure 12 shows the membrane and bending strains, measured in loading direction, at location 4, the corner of the grind-out. It can be seen that the membrane strains are approximately 8% lower for the grind-out with the single taper compared to the double taper grind-out. Bending strains are almost identical at the highest applied load.

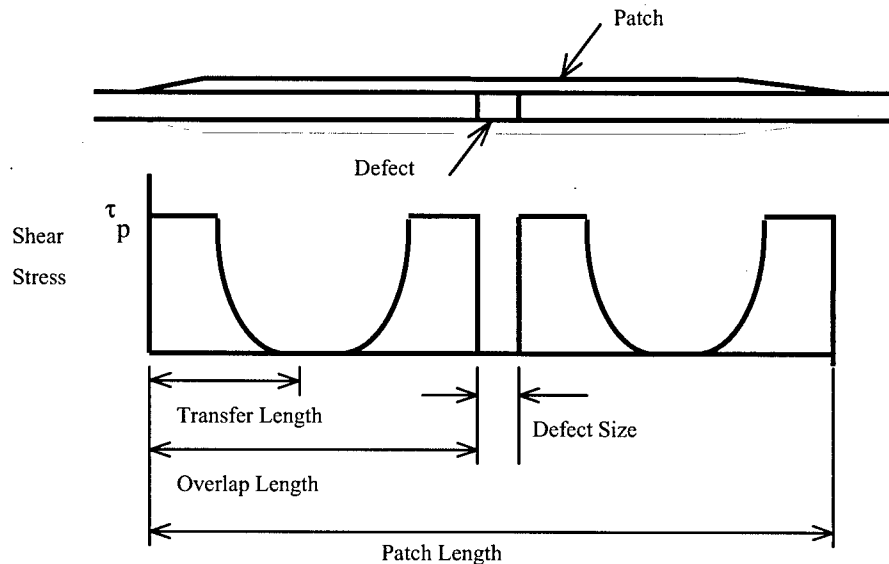
Figure 13: Relationship between transfer length, overlap length and patch length [C5033]

The length of the repair is based on the bond length that is required to transfer the load from the skin into the patch through the adhesive, also known as the transfer length. One transfer length consists of a plastic zone and an elastic zone. In the elastic zone, the shear stress is decreased from the plastic limit  $\tau_p$  down to a value approaching zero, see Figure 13.

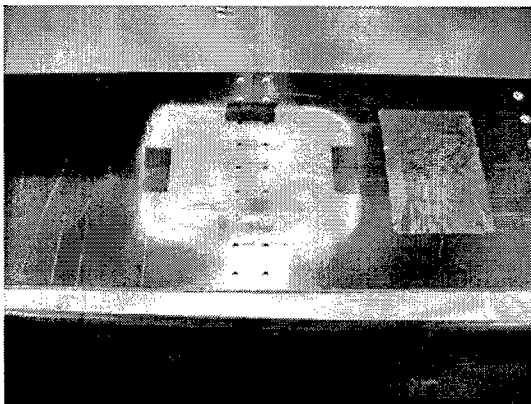
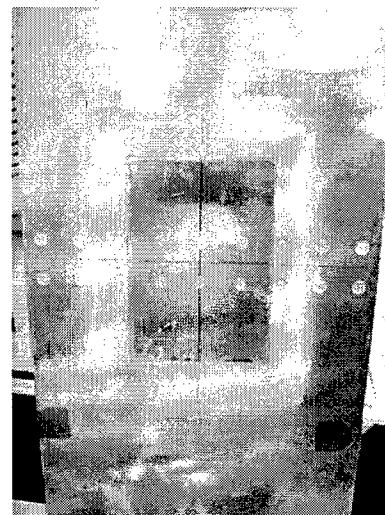
Figure 14: Aluminum repair before and after bonding

Since the removed material is replaced with material with similar thickness and Young's modulus, the stiffness ratio of the aluminum repair is 1.01. Figure 14 shows the specimen before and after bonding of the aluminum patch. As can be seen, the rivets have been re-countersunk through the repair.

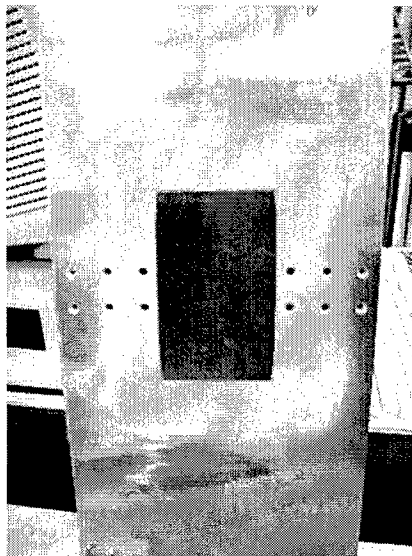
**Figure 15: Boron-epoxy repair after bonding**

Figure 15 shows the repair after bonding.

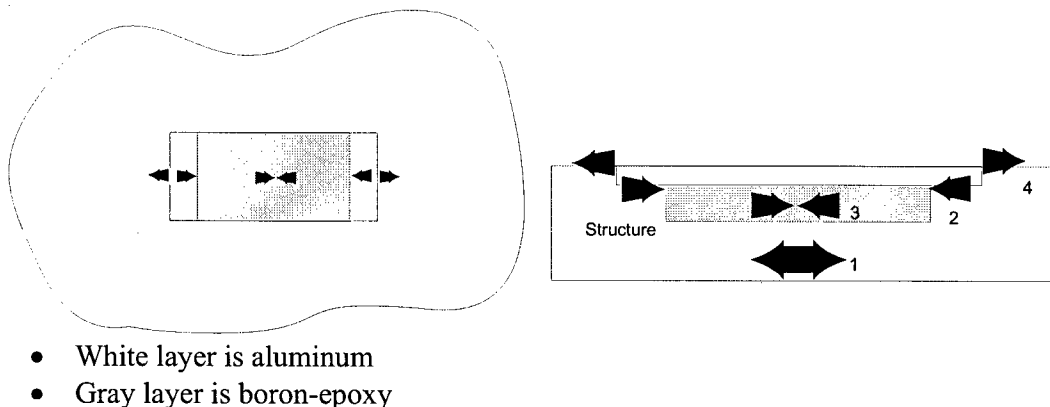
**Figure 16: Hybrid patch concept for a compression dominated structure**

By combining the best properties of both aluminum and boron-epoxy in the form of a hybrid patch, it is possible to create beneficial residual thermal stresses at both the patch tip and in the structure under the repair. Figure 16 [9] shows the residual thermal stress state for a hybrid patch concept that is beneficial for a compression dominated loading condition. The arrows do not imply externally applied loads, only thermal residual stresses.

In the case of a compression dominated loading situation the aluminum layer extends beyond the boron-epoxy layer. Since the effective CTE of the structure is lower than the free CTE of the aluminum layer of the patch, the aluminum layer will locally create residual thermal tensile stresses at the patch tip (location 4) in the structure, which are beneficial when the structure is predominantly loaded in compression. The residual thermal tensile stresses at location 4 can be deducted from the mechanically applied compressive loads, therefore reducing the problems of patch tip disbonding. Note however that there will still be compressive stresses in location 2, at the tip of the boron layer of the patch. These stresses however will be significantly lower than for the case where the entire patch is made out of boron, since the total residual thermal stresses are lower (because less boron was used), and because part of the load will stay in the aluminum layer of the repair instead of being transferred into the boron part of the patch.

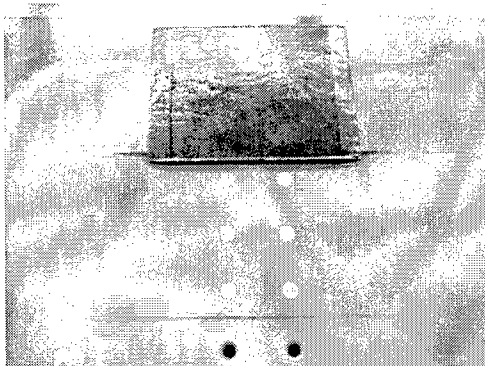
**Figure 17: Boron-epoxy plies of the patch with one layer of EA9696 adhesive. Note the hi-loks at the bottom of the grind-out**

The boron-epoxy part of the patch is bonded to the substrate using one adhesive layer of Hysol EA9696 0.06 lbs/ft<sup>2</sup>. The aluminum top layer of the patch is bonded to the boron-epoxy/aluminum substrate using the same adhesive. The combined thickness of all these layers filled up the grind-out depth completely. Figure 17 through Figure 19 show the hybrid repair before and after bonding.

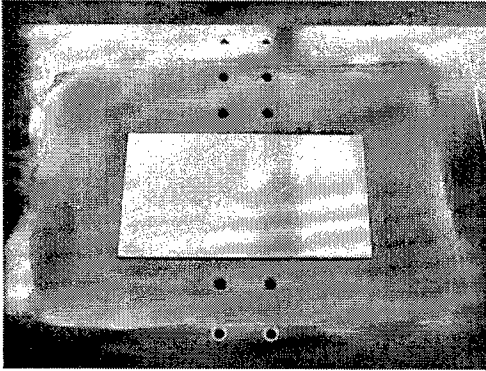
**Figure 19: Hybrid patch installed**

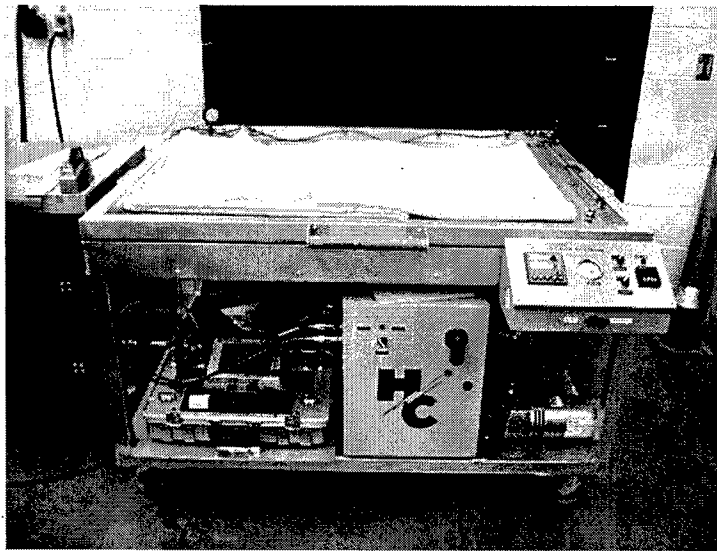
Figure 20: Heatcon vacuum table

Bonding was done using a Heatcon vacuum table, see Figure 20 and Figure 21. The boron-epoxy and hybrid patches were co-cured during the adhesive cure-cycle.

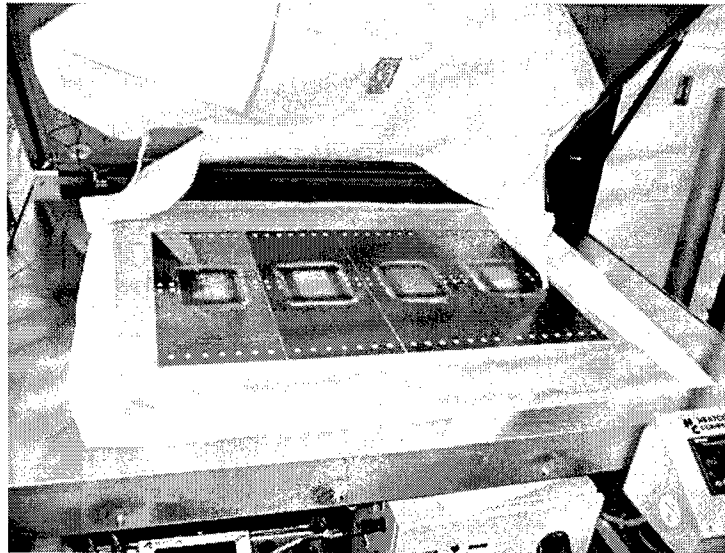
**Figure 21: Specimen with aluminum repairs in vacuum table**

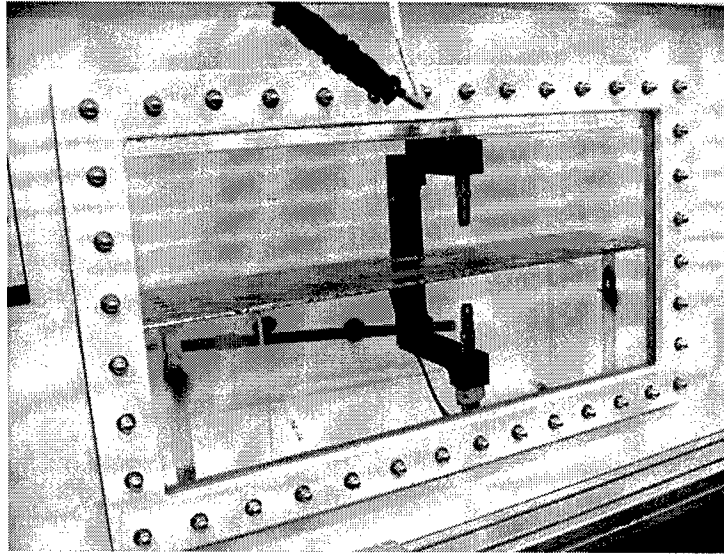
**Figure 22: Specimen with bonded repair in c-scan tank**

Since disbonds and delaminations were a concern during the compression loading, specimens were taken out of the test frame at regular intervals, disassembled and c-scanned (Figure 22) to look for any signs of disbonding.

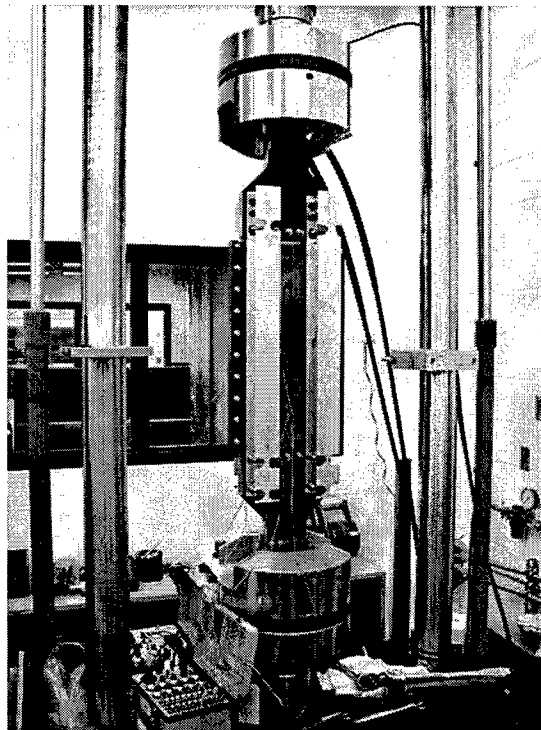
**Figure 23: MTS 810 110 kip hydraulic load frame**

Testing was done using a MTS 810 110 kip (Figure 23) and 55 kip test frame, running TestStar IIs and TestStar IIm. The constant amplitude tests were tested at a frequency of 4 Hz, the spectrum testing was ramp rate controlled at 250 kN/sec. Humidity and temperature were monitored during testing.

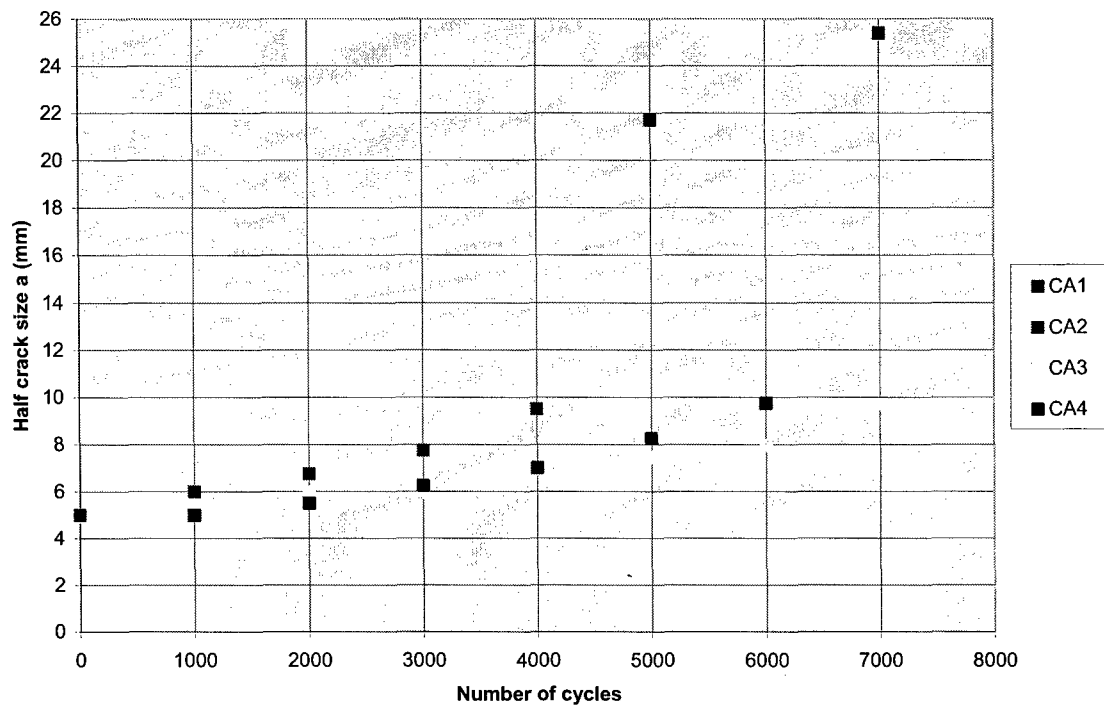
Figure 24: Specimens without repair, CA loading

Figures 24 through 27 show crack growth curves for the specimens tested under constant amplitude fatigue loading. Figure 28 shows a comparison of an unrepaired specimen and the three different types of repairs (the data of the most "average" specimen is shown for each type of specimen). More detailed crack growth data can be found in appendix A.

As can be seen from Figure 24, the unrepaired specimen showed rapid crack growth. Specimen CA1 had one of the crack tips link up to the adjacent rivet hole within the first measurement interval, which was initially set at 5000 cycles. After finishing specimen CA1 the intervals were reduced to 1000 cycles. Specimen CA4 linked up both crack tips at 7000 cycles. Testing of specimens CA2 and CA3 was stopped before the cracks could extend to the adjacent fastener holes.

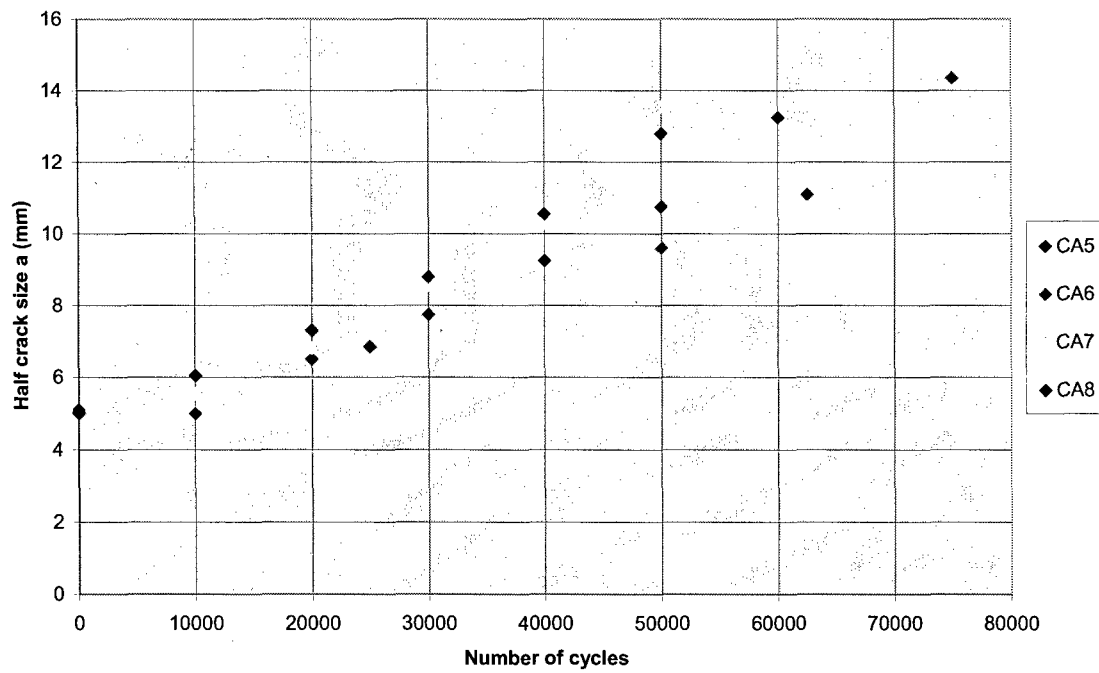
Figure 25: Specimens with aluminum repairs, CA loading

Figure 25 shows the crack growth curves for the four specimens with aluminum repairs tested in CA tension. Figure 28 shows that, although the aluminum repair has a stiffness ratio that is too low (below the desired stiffness ratio of 1.0) now that the remaining substrate is cracked, the aluminum repairs extended the fatigue life of the specimen significantly when compared to the unrepaired situation.

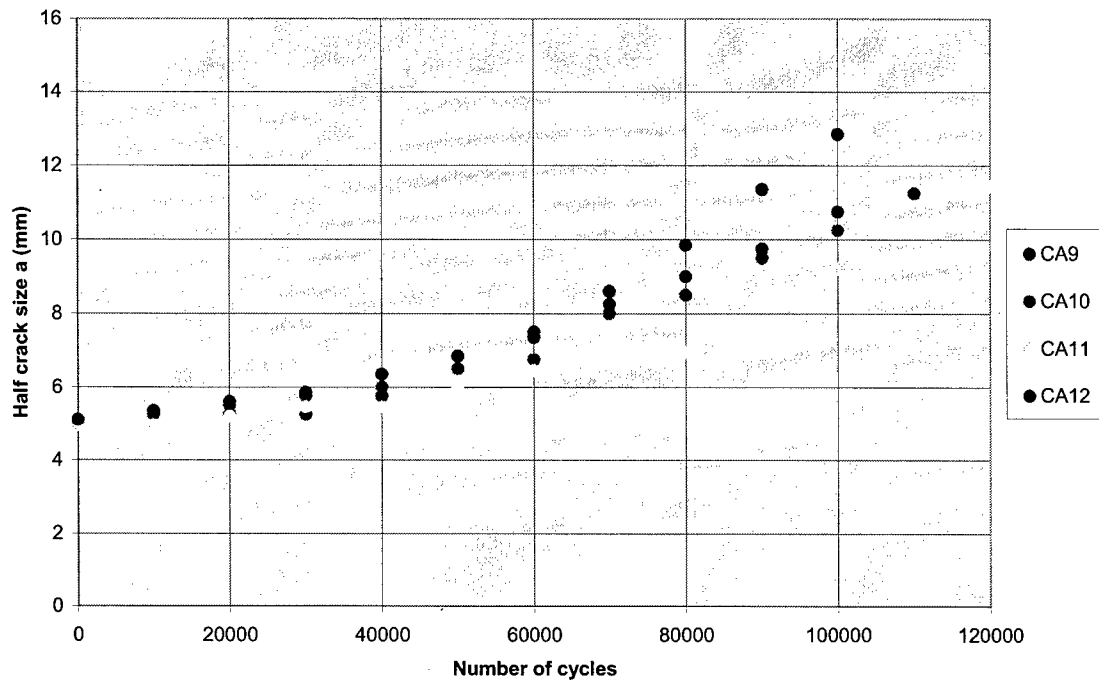
Figure 26: Specimens with boron-epoxy repairs, CA loading

Figure 26 shows the crack growth curves for the four specimens with boron-epoxy repairs. Figure 28 shows that the boron-epoxy repair easily outperforms the aluminum repair. The benefit of the higher stiffness ratio of the boron-epoxy repair outweighs the disadvantage of the higher residual thermal stresses.

As can be seen from Figure 26, the cracks grow very slow in the beginning of the test, due to the high stress reduction under the repair. Some scatter can be seen but most is due to the differences in the early phase of the tests. No unexpected failure modes were seen during the tests. None of the rivet holes other than the test hole showed signs of crack nucleation.

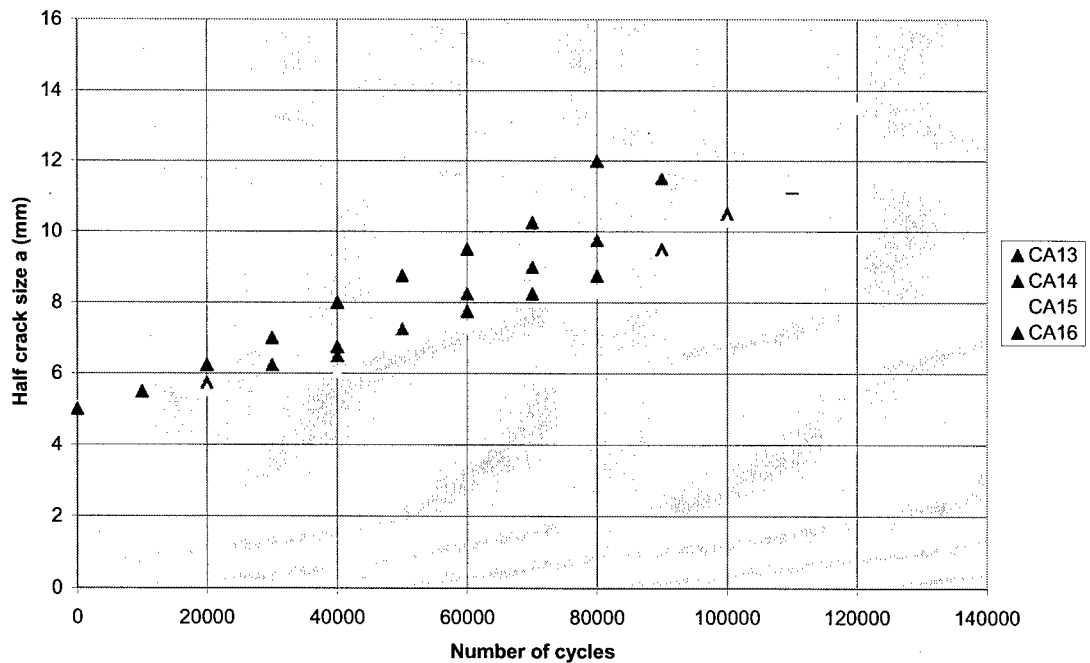
Figure 27: Specimens with hybrid repairs, CA loading

Figure 27 shows the crack growth curves for the hybrid repairs. Figure 28 shows the performance of the hybrid repairs compared to the other repair types.

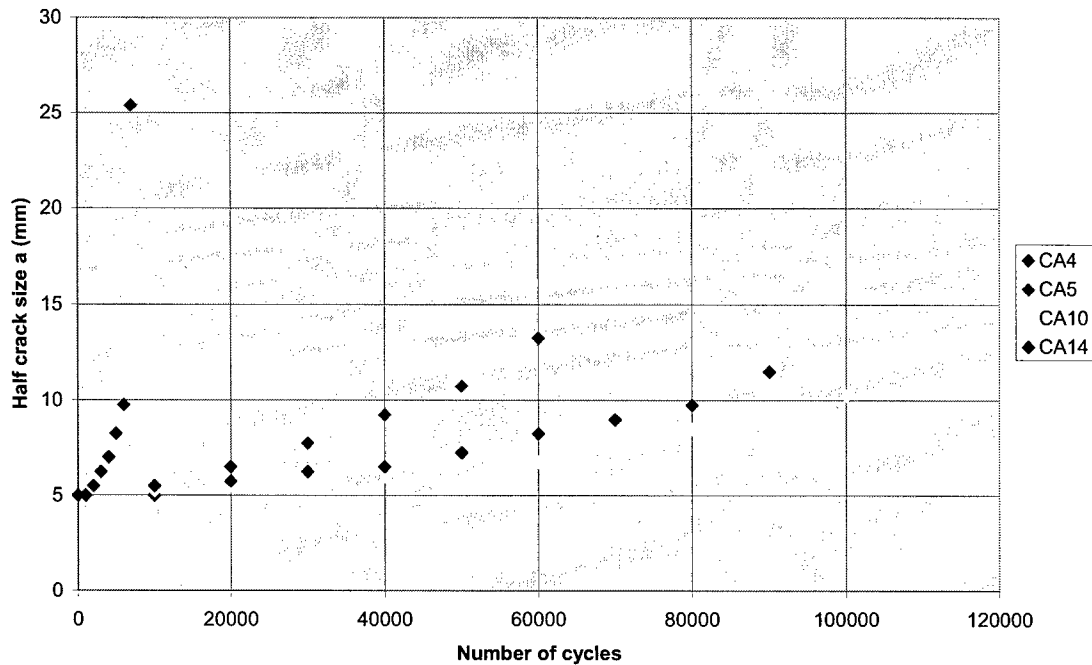
Figure 28: Crack growth curves for specimens with and without repairs, CA loading

As can be seen in Figure 28, the hybrid repairs perform better than the aluminum repair. Despite the fact that the thermal residual tensile stresses under the boron-epoxy repairs are higher than for the hybrid repairs, the hybrid repair performs similar or slightly below the boron-epoxy repair. This can be explained by the fact that the hybrid patch is thicker than the boron patch. The advantage of a smaller CTE mismatch for the hybrid patch is counteracted by shear lag in the thicker hybrid patch, which is most noticeable in the absence of bending [11].

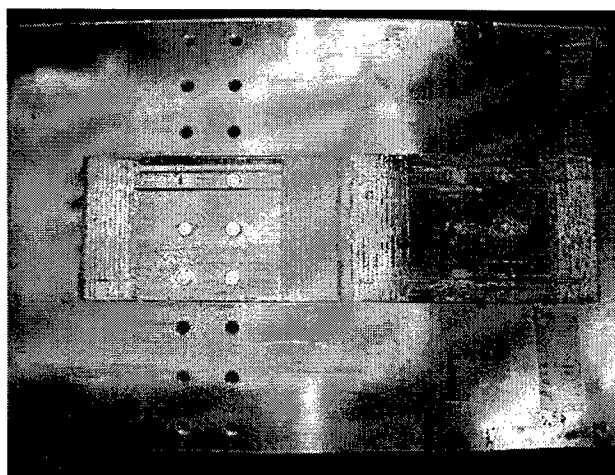
**Figure 30: Boron-epoxy patch after compression test**

Figure 30 shows a photo of specimen CA20 after compression testing. Although already partially disbonded, the patch had to be peeled off before this photo could be taken. As can be seen from the photo, the bond line has failed between the adhesive and the boron-epoxy, in the resin-rich interface. All of the adhesive is on the aluminum specimen and the boron-epoxy has hardly any adhesive on it. Normally, an adhesion failure mode like this points towards poor surface preparation. However, remember that the boron-epoxy was co-cured and there is no surface preparation involved on the boron-epoxy side of the bond line. The fact that this specific interface failed is in itself not surprising, considering that this interface is the highest loaded interface of the repair. Since the film adhesive has superior properties compared to the epoxy in the boron pre-preg, the resin-rich part is most likely to fail.

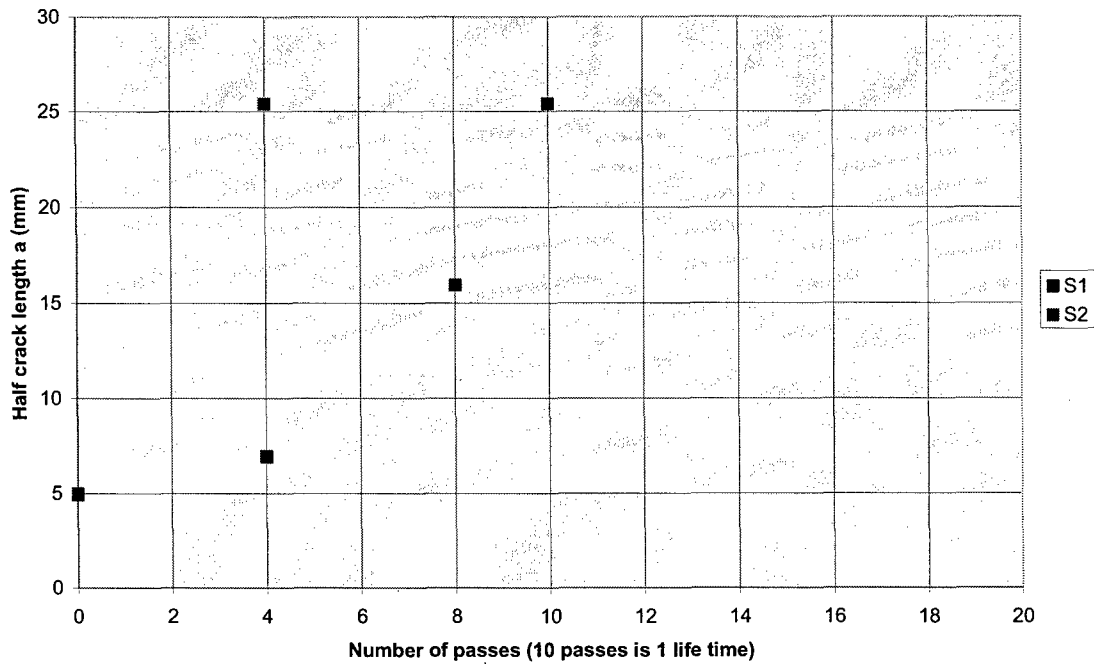
Figure 31: Specimens without repair, spectrum loading

Table 6 shows the specimens that were tested under spectrum loading. Figures 31 through Figure 34 show the crack growth curves for the unrepaired specimens and the three different types of repairs. Figure 35 shows a comparison of the different types of repair, and Figure 36 shows the same curves as Figure 35 but now with the unrepaired specimen included.

Figure 31 shows the results for two unrepaired specimens. As can be seen, cracks did grow significantly when loaded using the upper wing skin spectrum, with pre-existing damage. For specimen S2, the crack linked up to the adjacent rivet holes within four spectrum passes, or 0.4 life time. Specimen S1 also linked up to the adjacent rivet holes within one life time.

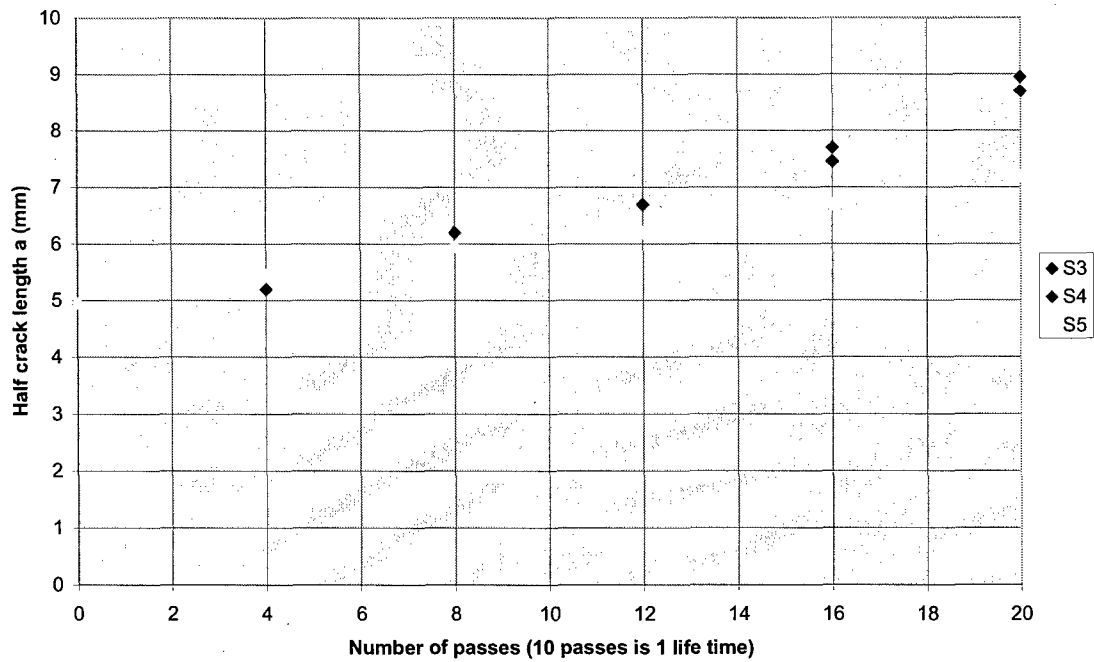
Figure 32: Specimens with aluminum repairs, spectrum loading

Figure 32 shows that the aluminum repair performed very well under spectrum loading. Crack growth was reduced significantly compared to the unrepaired specimens. The difference between the aluminum repair and the hybrid repair is slightly smaller to what was seen in the results from the constant amplitude fatigue tests. It appears that the aluminum is benefiting from the lack of thermal residual stresses, the cracks under the aluminum repairs do not grow while loaded in compression. However, crack growth is still very minimal considering that two life times were tested, and keep in mind that only twice the remaining life time of the aircraft has to be demonstrated. Also, the assumption is that no crack is present when the repair is bonded into the grind-out. The aluminum repair showed no signs of unexpected failure modes, such as crack nucleation in the patch itself or in the specimen at the patch tip, or disbonding, see appendix B.3. There was also no sign of crack initiation in any of the other rivet holes under the repairs.

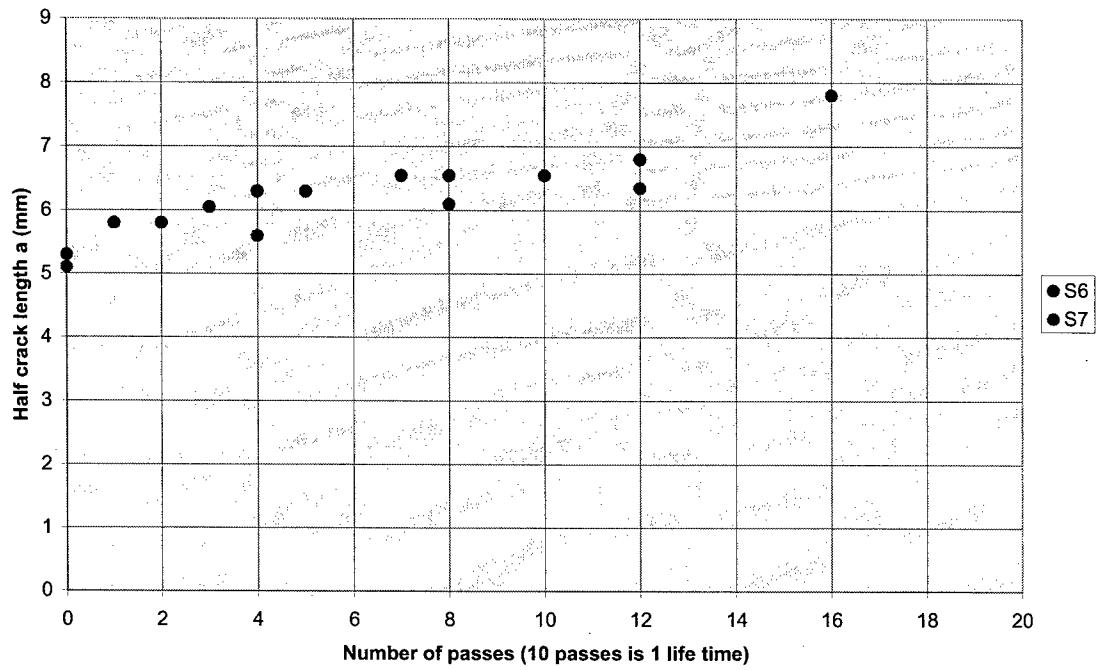
Figure 33: Specimens with boron-epoxy repairs, spectrum loading

Specimens with boron-epoxy repairs showed crack growth that was irregular, see Figure 33. Delaminations were found between 1.2 and 1.6 life times, see appendix B.6. They were initially found using coin tapping, and then confirmed using c-scan. Crack growth did not go up dramatically since the patch is still transferring load over the cracked area as long as the patch remains bonded in the cracked area. The disbonding of the boron-epoxy patches under CA compression loading was already a serious indicator but was not yet conclusive since the loads that were used were not a direct representation of the actual loading conditions. Disbonding of the boron-epoxy patches under spectrum loading however disqualifies this repair for this particular application.
